NWC TP 5812

Baseline Data From an A-4 Cockpit in Simulated Carrier Deck Fire

by
Anthony San Miguel
Systems Development Department

AUGUST 1976

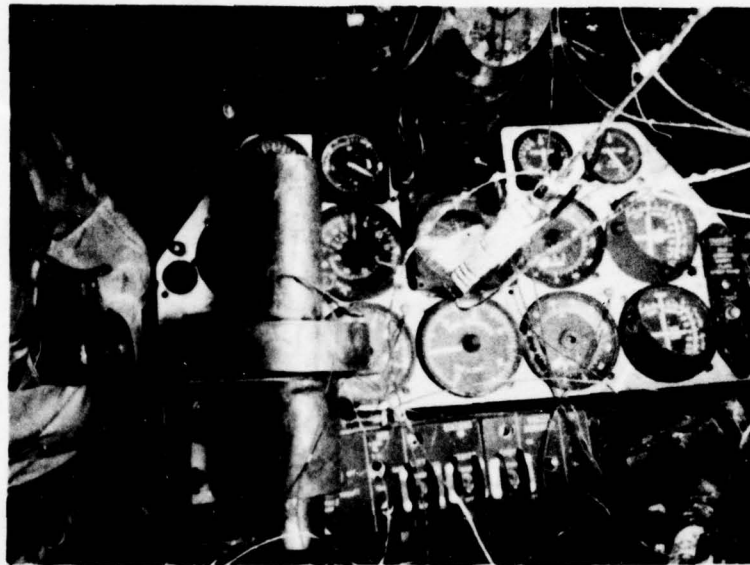
FIGURE H-6. Post-Test Photo of Smoke Transducer Mounted in Cockpit of Navy A-4. (Neg. LHL 187342)

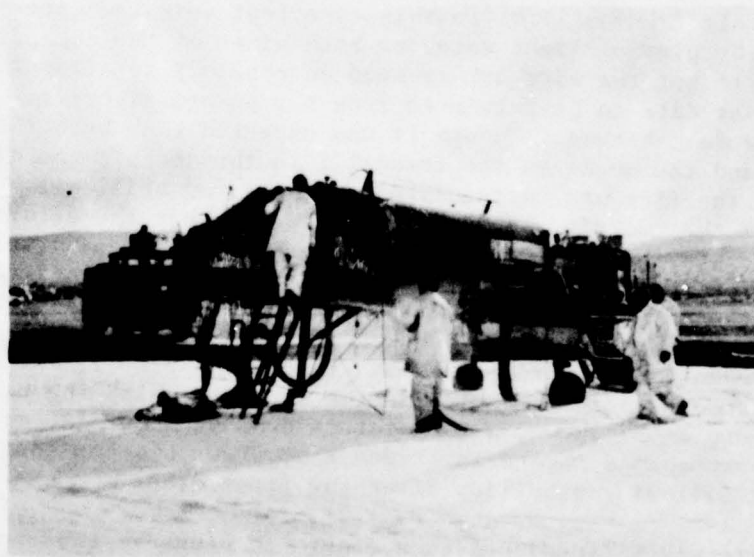
**FIGURE L-2. View of Test Site Just After Fire Was Extinguished.
(Neg. LHL 187347)**

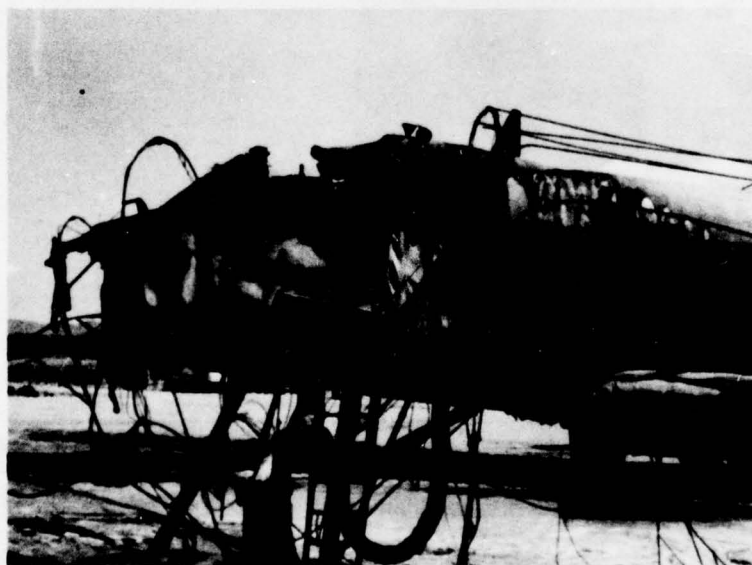
Significant structural failure occurred in the canopy, the nose cone, the sheet aluminum on both sides and under the floorboard station housing electrical and hydraulic lines (Appendix M). Buckling and melting caused separations that could admit flames at the juncture of the floorboard and the forward bulkhead and under the seat. The rubber fuel tank full of JP-5 fuel just behind the cockpit was directly exposed to flames from below, but suffered no damage.

FIGURE M-1. Port Side of A-4 Aircraft After Fire Test. (Compare with Figure A-3 before fire.) (Neg. LHL 187322)

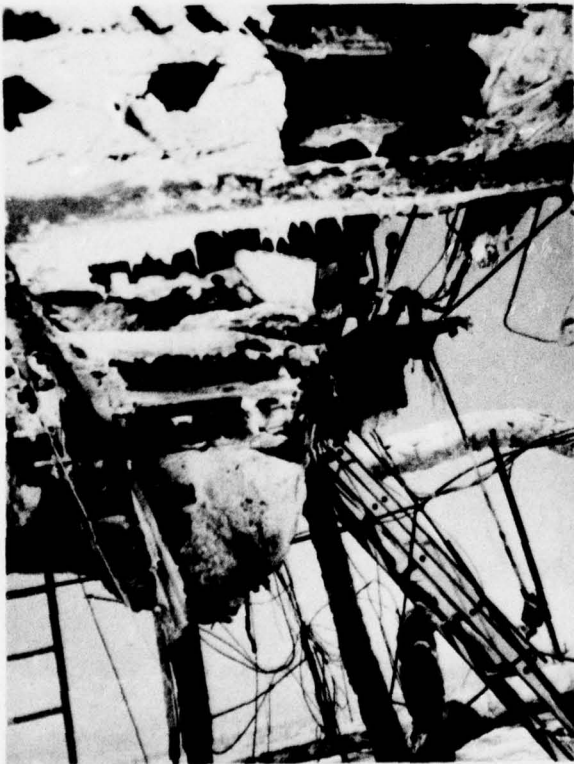
FIGURE M-3. View From Beneath
A-4 Aircraft Looking Forward After
Fire Test. (Neg. LHL 187345)

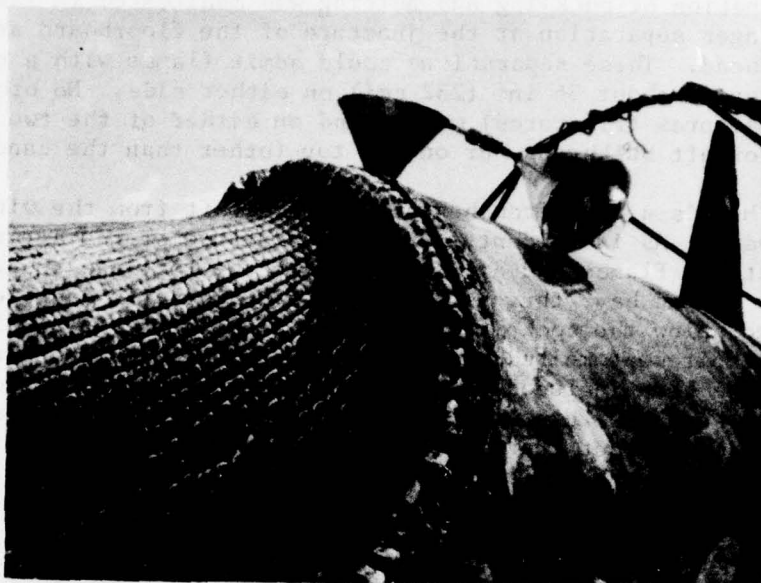
FIGURE M-4. Post-Test View of Canopy From Port Side. Note broken TM antenna on top of A-4. (Neg. LHL 187329)

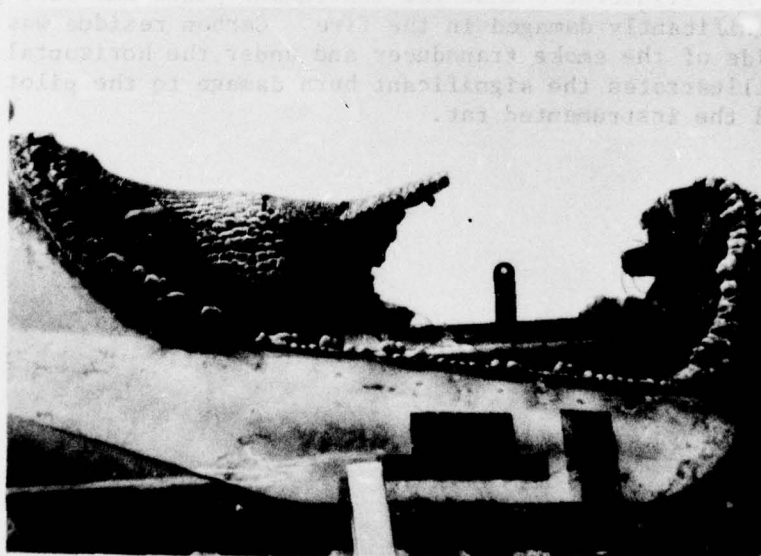
FIGURE M-5. Post-Test View of Canopy From Starboard Side. (Neg. LHL 187331)
